Providence College Tree Inventory & Management Plan | 2015

Submitted by
The Bartlett
Inventory Solutions
Team

In April, 2015, the Bartlett Inventory Solutions Team from Bartlett Tree Experts conducted an inventory of trees on the Providence College campus. We identified 1,489 trees that included 82 species. The attributes that we collected include tree latitude and longitude, size, age and condition class, and a visual assessment of tree structure, health, and **vigor**.

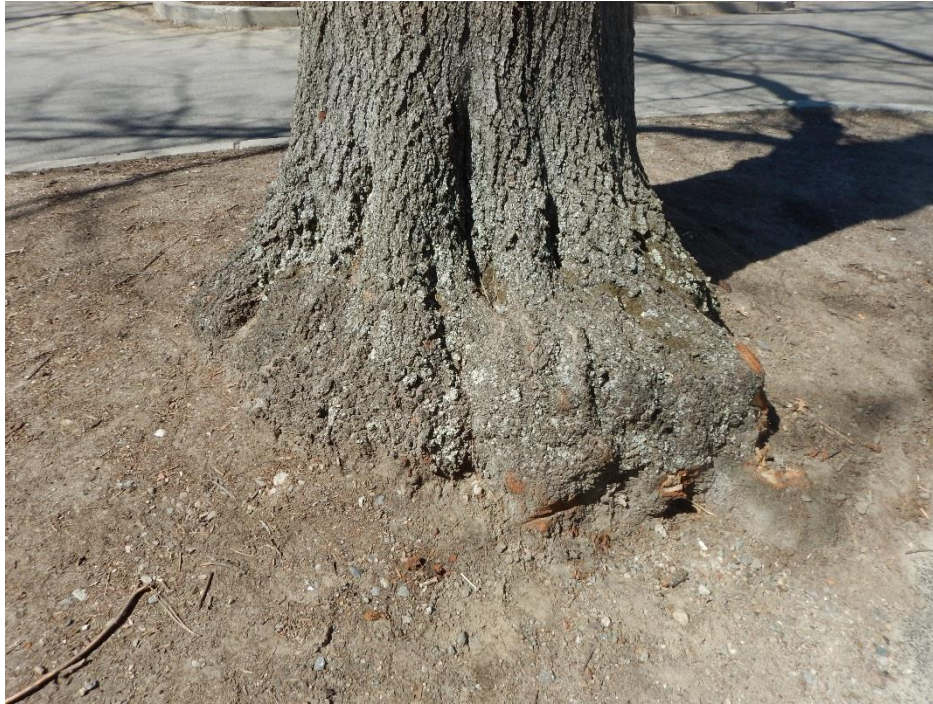
Figure 4: Tree #281 recommended for Root Invigoration™ due to compaction of the root zone.

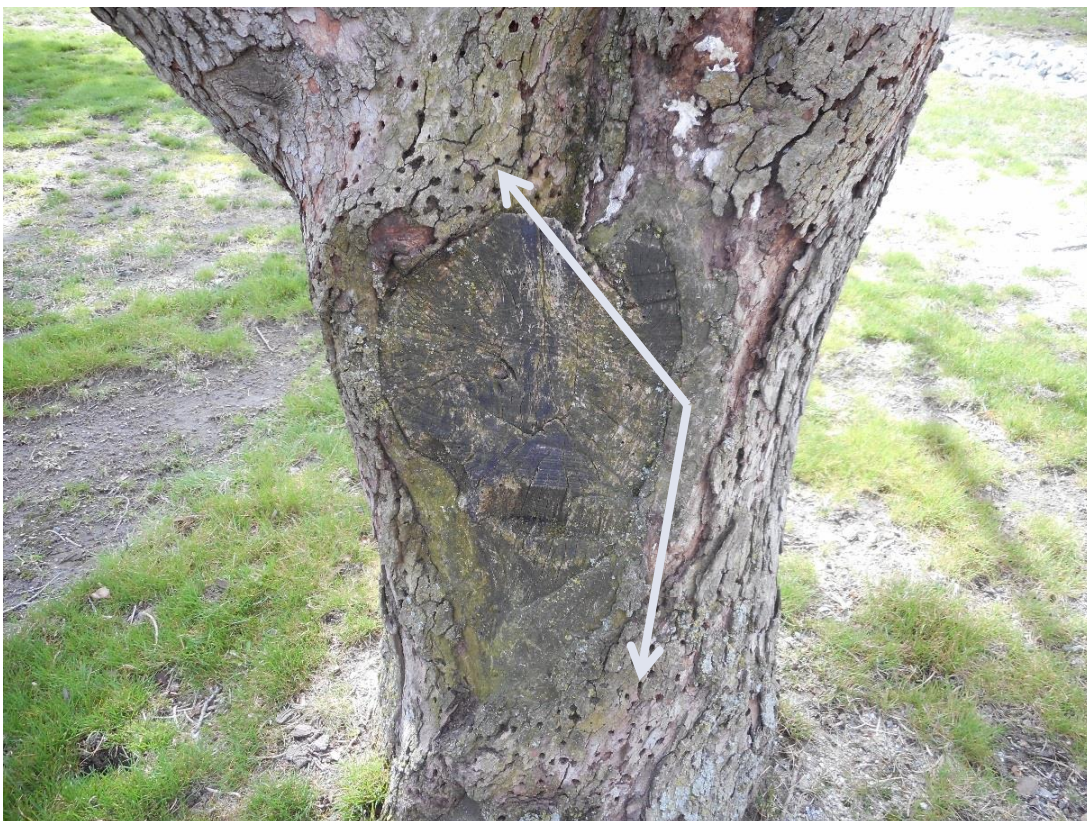
Figure 13 : Tree #574 with borer damage.

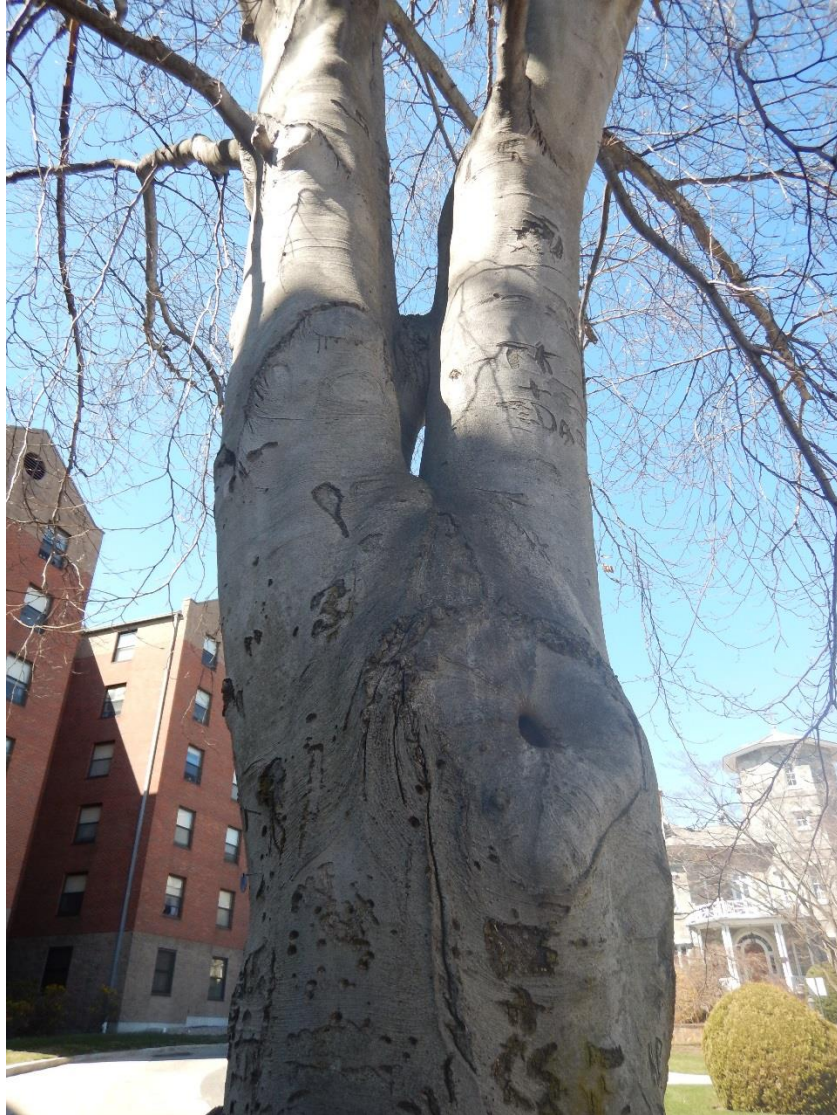
Figure 22: Tree #344 recommended for cabling due to the presence of co-dominant leaders.

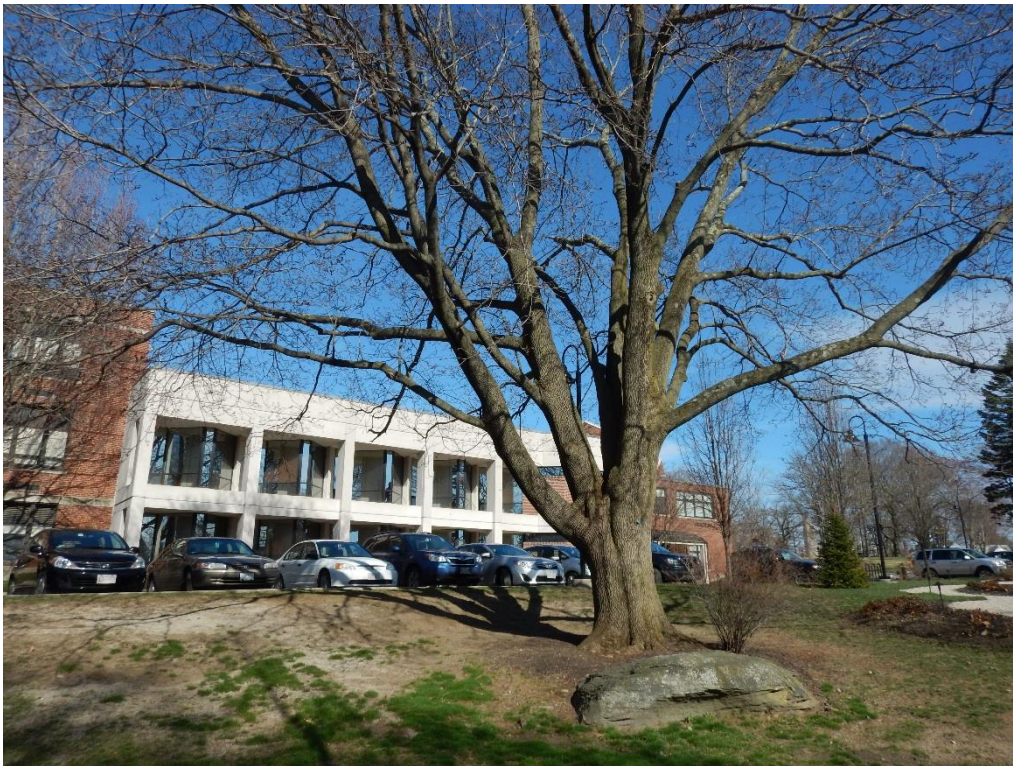
Figure 23: Tree #472 recommended for removal due to multiple defects, including co-dominant leaders, stem cavities and overextended branches.

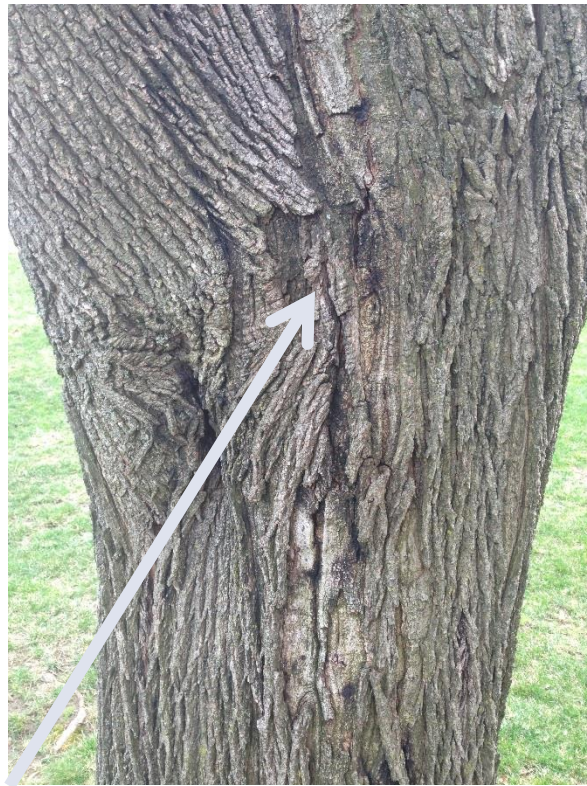
Figure 24: Included bark on Tree #108 necessitates a Level 3 *advanced assessment* to more thoroughly assess risk of failure.

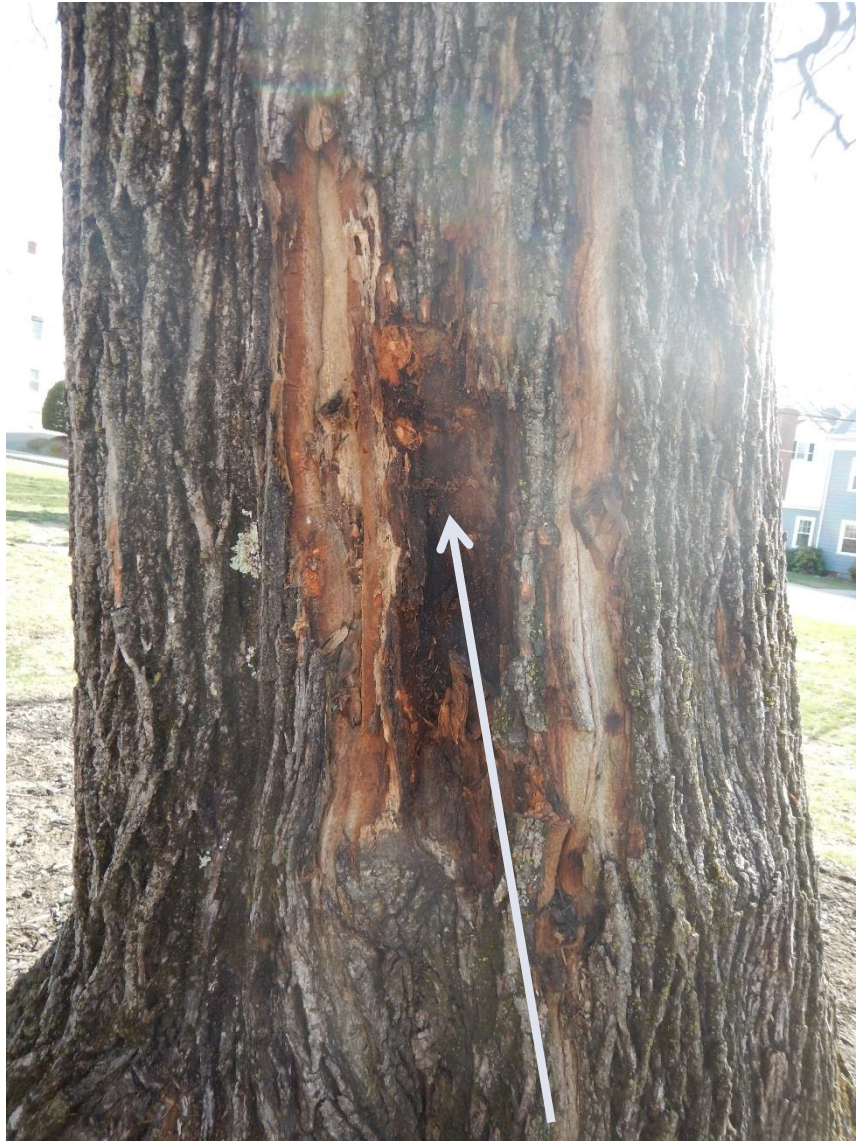
Figure 26: Tree #470 exhibiting a wound on the stem.
