Providence College Tree Inventory & Management Plan | 2015

Submitted by
The Bartlett
Inventory Solutions
Team

In April, 2015, the Bartlett Inventory Solutions Team from Bartlett Tree Experts conducted an inventory of trees on the Providence College campus. We identified 1,489 trees that included 82 species. The attributes that we collected include tree latitude and longitude, size, age and condition class, and a visual assessment of tree structure, health, and **vigor**.

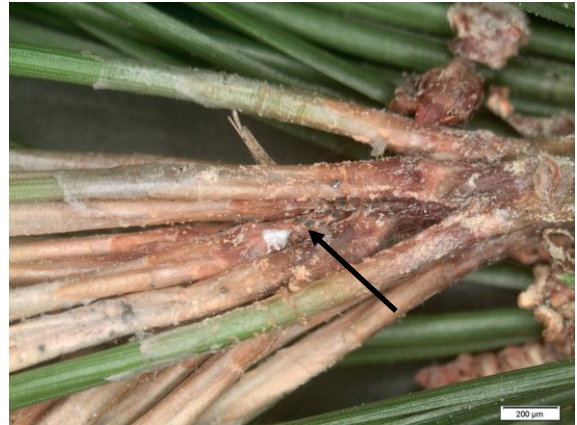
Another pest, which causes dead tips on pine, is the pine tip moth. To distinguish tip blight from tip moths, bend the dead tip; if it breaks and is hollow it is probably pine tip moth, if flexible it is probably tip blight. In the late summer fungal fruiting structures (pycnidia) form on dead needles. They appear as small black dots, first under the fascicle sheath, then up the needle (Figure 1).

Figure 1: Needles infected with *Sphaeropsis sapinea*. Arrow points to the fungal fruiting structures (pycnidia).

infected, all of the above recommendations should be followed as well as pruning and applying fungicides. Pruning will not provide effective control of the disease. However, dead tips may be pruned to improve the appearance of the tree. If

pruning is the only management method used, cones should also be removed since they are a major source of inoculum. Fungicide treatments should begin at budbreak and be repeated two or three times at 14-day intervals.

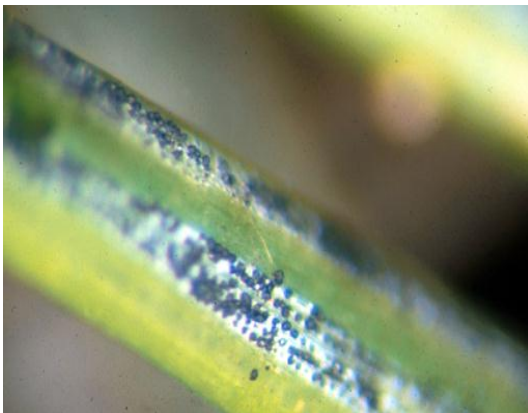
Needlecast fruiting bodies on spruce needles.

Needlecast can be controlled by making protective applications of a properly registered fungicide when the needles are half-grown and again when fully developed.

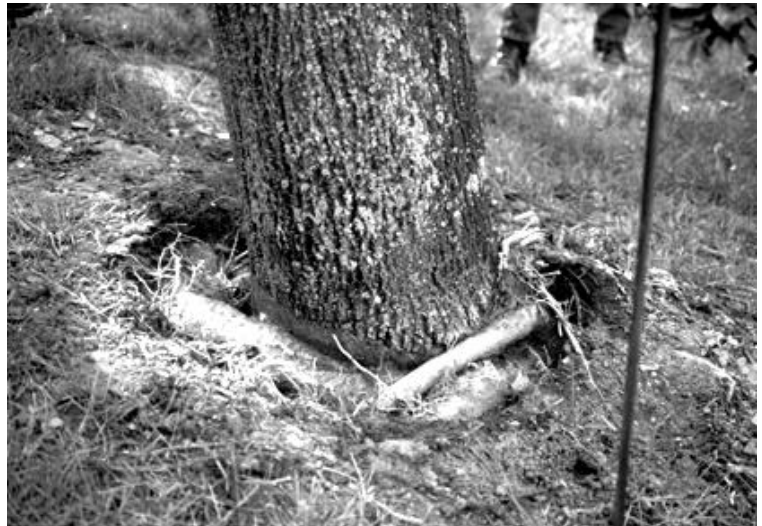
When plants are held in containers for too long a period of time, many roots begin to circle around the pot (Figure 1). These eventually can girdle the tree. When planting trees and shrubs with this condition, be sure to loosen these roots from the container root ball and spread them out in the planting hole before back filling. Circling roots two or more years old will be woody and may have to be cut and removed from the root system, because they will have taken the permanent shape of the container and cannot bend enough

Figure 1. Roots growing in containers frequently begin circling if held in the container for too long.

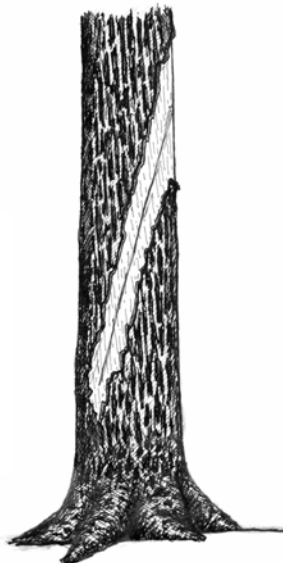
Figure 1. Moderate lightning damage showing spiral bark damage and groove in the sapwood.

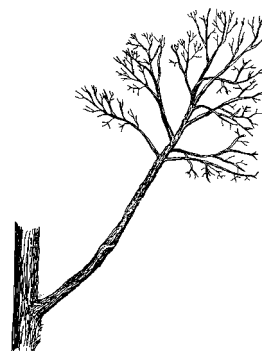
Improper pruning
